Lateral Migration of the Colorado River And other tales of the Moab Mill Site Fact - or Science Fiction?

John C Dohrenwend, PhD
Geosciences Department
The University of Arizona

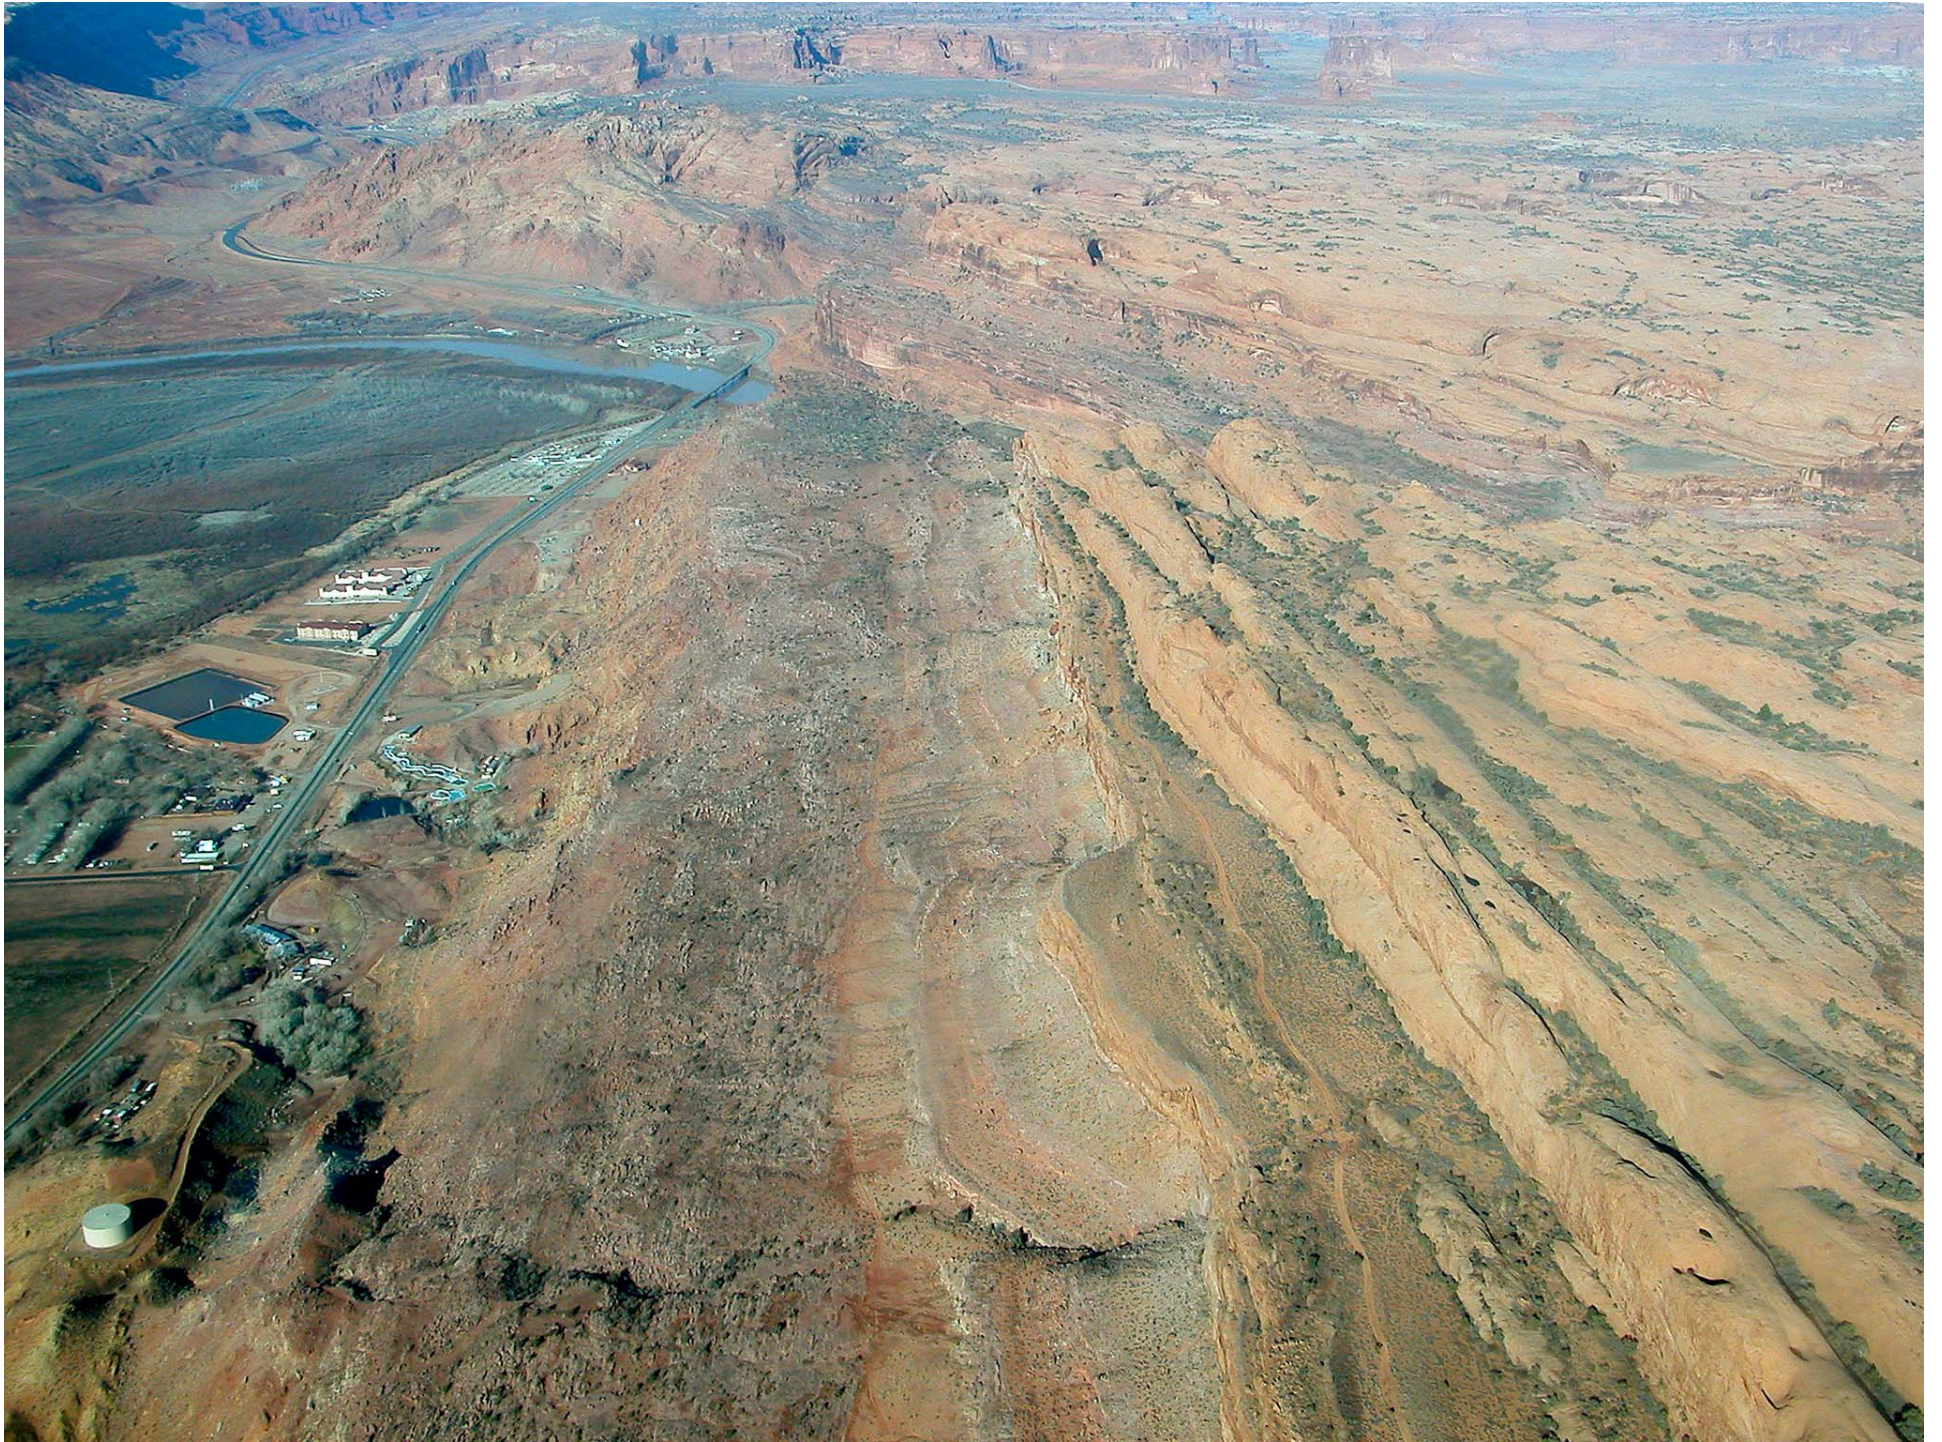
An aerial photograph of a desert canyon landscape. The Colorado River flows through the center, winding between steep, layered rock walls. In the foreground, a large, flat area contains several industrial buildings, a parking lot, and a road. The river continues into the distance, where it turns a sharp bend. The surrounding terrain is arid, with sparse vegetation and prominent geological features like mesas and buttes.

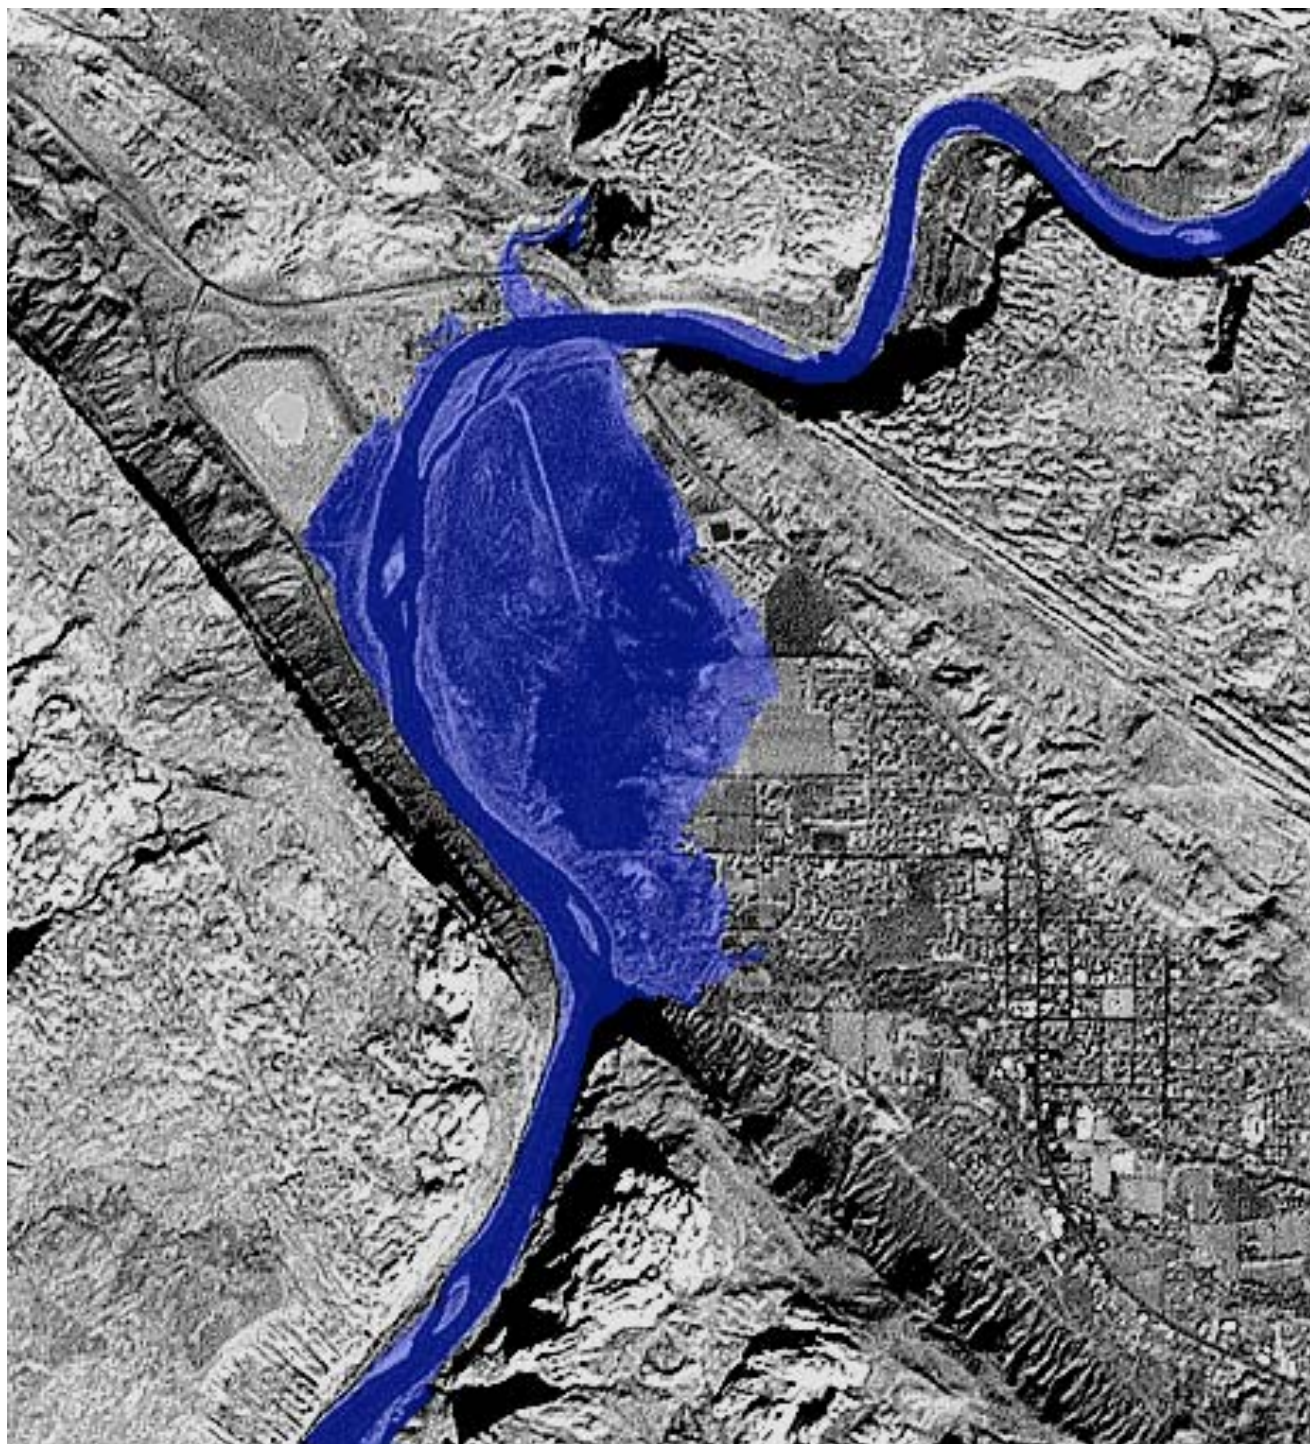
Landsat 5 Satellite Image - May 26, 1984 - 66,500 cfs
